Manhole Inspection Summary

Manhole # S67S__006MH

Location Address: **1542 Charlotte Ave.**

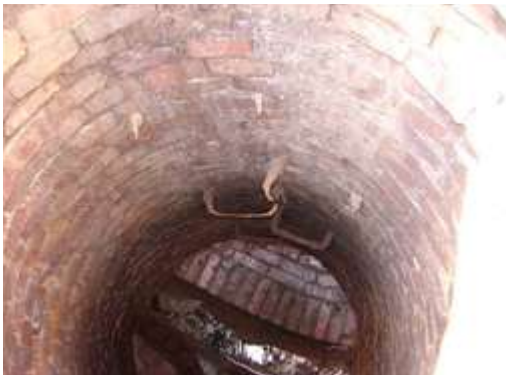
Defect 2

Infiltration in lower half of barrel

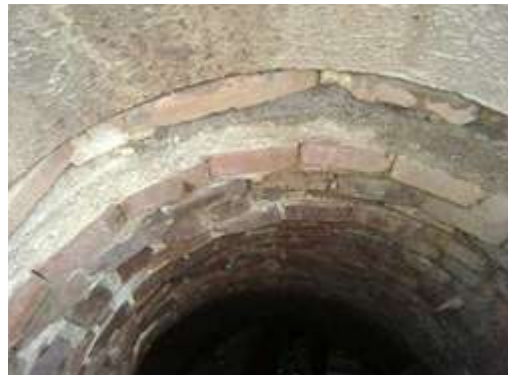
Defect 1

Condition: ☐ Sound ☐ Cracked ☐ Root Intrusion ☒ **Loose Brick** ☐ Deteriorated

Infiltration: ☐ None ☒ **Joint** ☐ Cracks ☒ **Mortar** ☐ Roots ☐ Wall

cracked mortar at frame adjustment

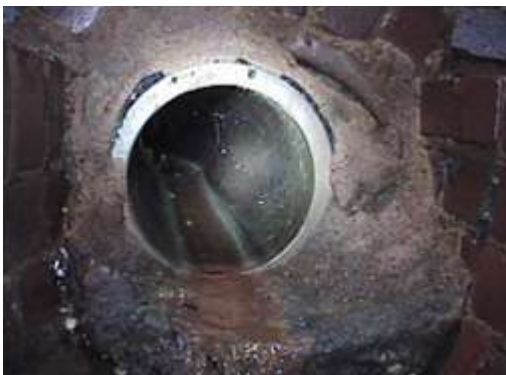
Defect 3

cracked pipe seal 9:00-3:00 on incoming 6 o'clock

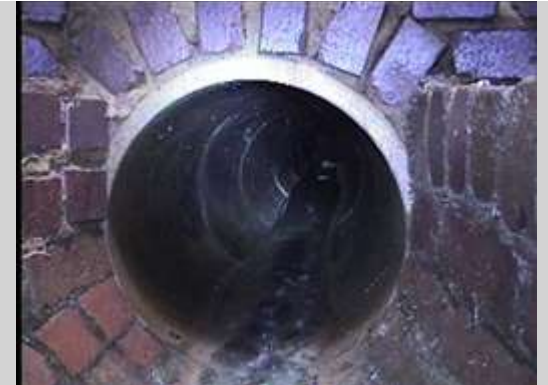
12 O'Clock Outflow

Pipe Height: **12** (in.) Rod and Bar (Angled)
Pipe Material: **Clay** ☐ Pipe Lined
Invert Depth: **10.75** (ft.) Flow Characteristics: **Slow**
Deposits: ☒ None ☐ Mud ☐ Sludge ☐ Debris ☐ Grease
Silt Depth: (in.) Deposits Extent:
Infiltration: **None** Pipe Seal Cond: **Sound**

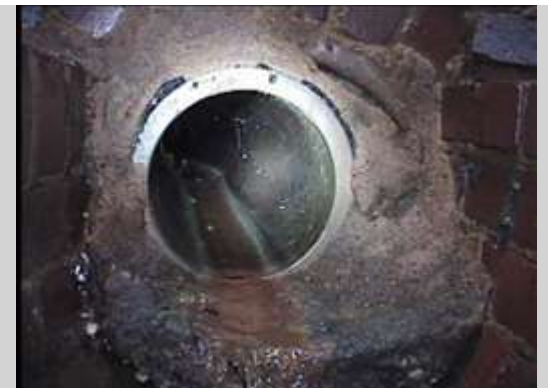
6 O'Clock Inflow

Pipe Height: **6** (in.) Rod and Bar (Angled)
Pipe Material: **Clay** ☐ Pipe Lined
Invert Depth: **10.33** (ft.) Flow Characteristics: **Slow**
Deposits: ☒ None ☐ Mud ☐ Sludge ☐ Debris ☐ Grease
Silt Depth: (in.) Deposits Extent:
Infiltration: **None** Pipe Seal Cond: **Unknown**

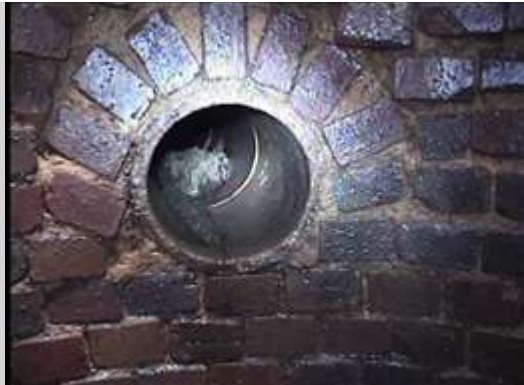
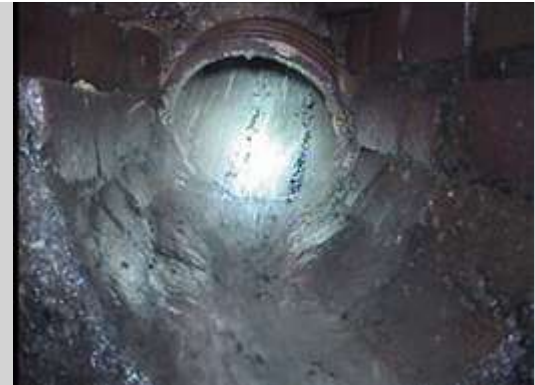
9 O'Clock Inflow

Drop Condition: **Partly Clogged**
